## **Analysis of Brownfield Cleanup Alternatives**

Central Building  
2425 Washington Avenue  
Baker City, OR 97814

April 28, 2022

Stantec Consulting Services Inc.  
601 SW 2nd Avenue #1400  
Portland, OR 97204

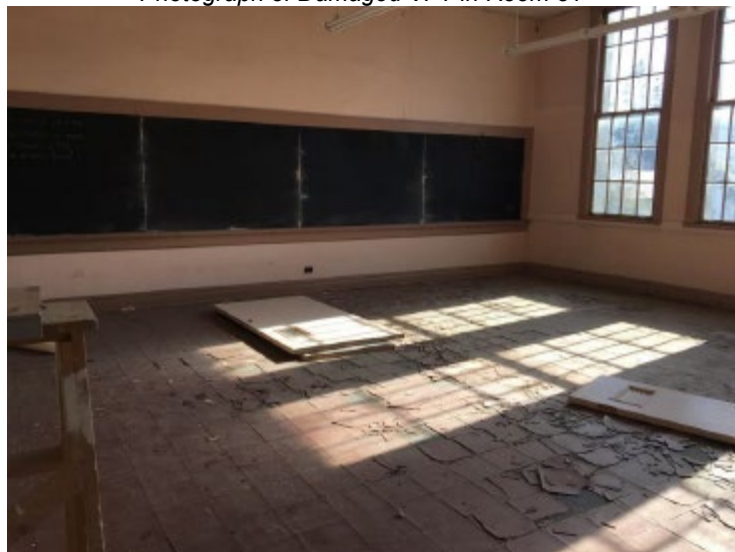
be prohibited and barred. For example, in Room 31, VFT in poor condition is present. The door into Room 31 should be closed and locked, and signage indicating the hazard within Room 31 and prohibiting access posted on the door.

*Photograph of Damaged VFT in Room 31*
